**Incidental Harassment Authorization
Final Marine Mammal Monitoring Report for
August 2015 to August 2016**

**Washington State Department of Transportation
Ferries Division**

**Mukilteo Multimodal Project Tank Farm Pier Removal
June 24, 2016**

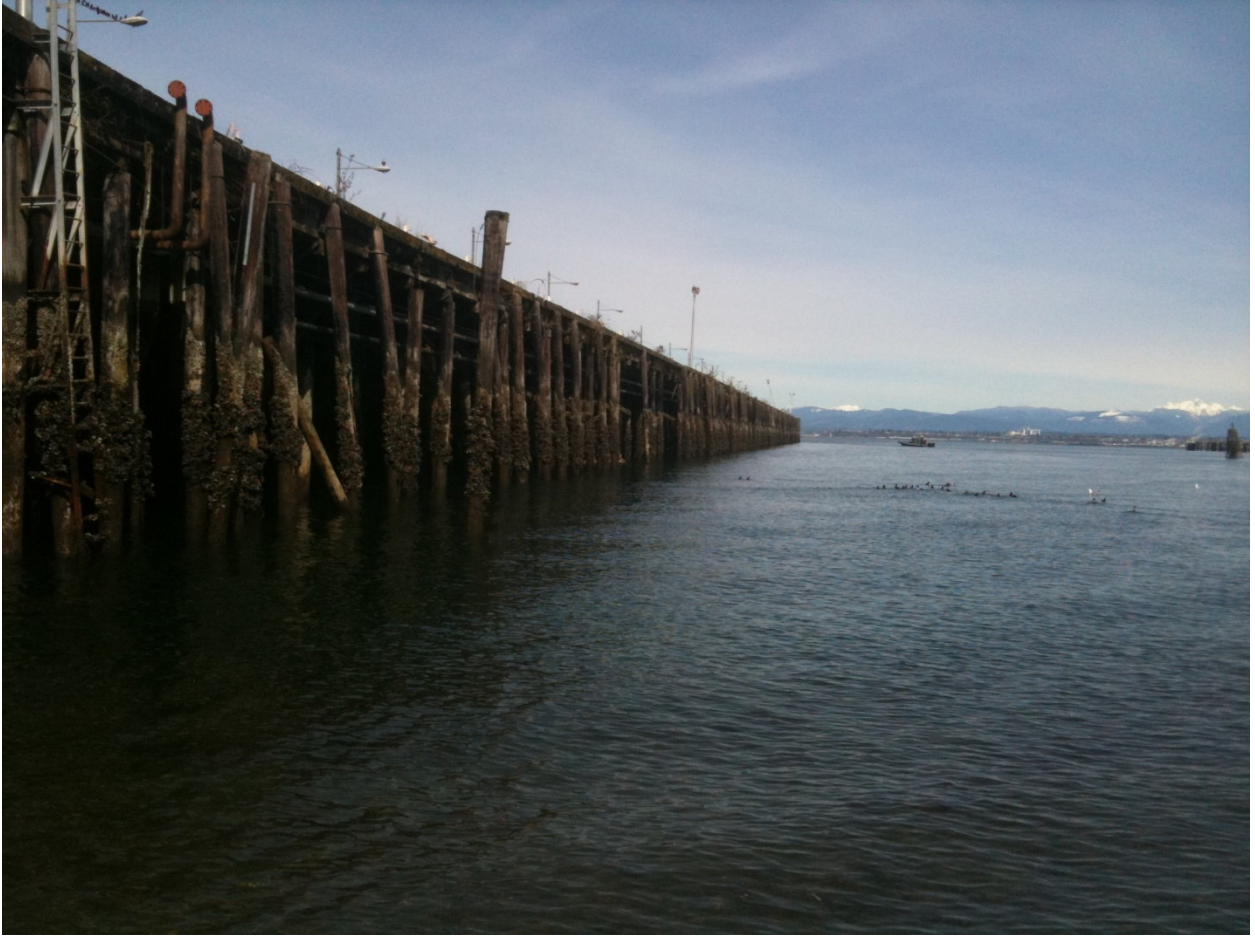
Figure 2-2 Former Mukilteo Tank Farm Pier

The Mukilteo Tank Farm Pier, which has not been used for fuel transfers since the late 1970s, covered approximately 138,080 ft² (3.17 acres) over-water and contained approximately 3,515 12-inch diameter creosote-treated piles which were removed (see Appendix A – Project Sheets 1 and 2). Demolition of the pier removed approximately 7,300 tons of creosote-treated timber from the aquatic environment.

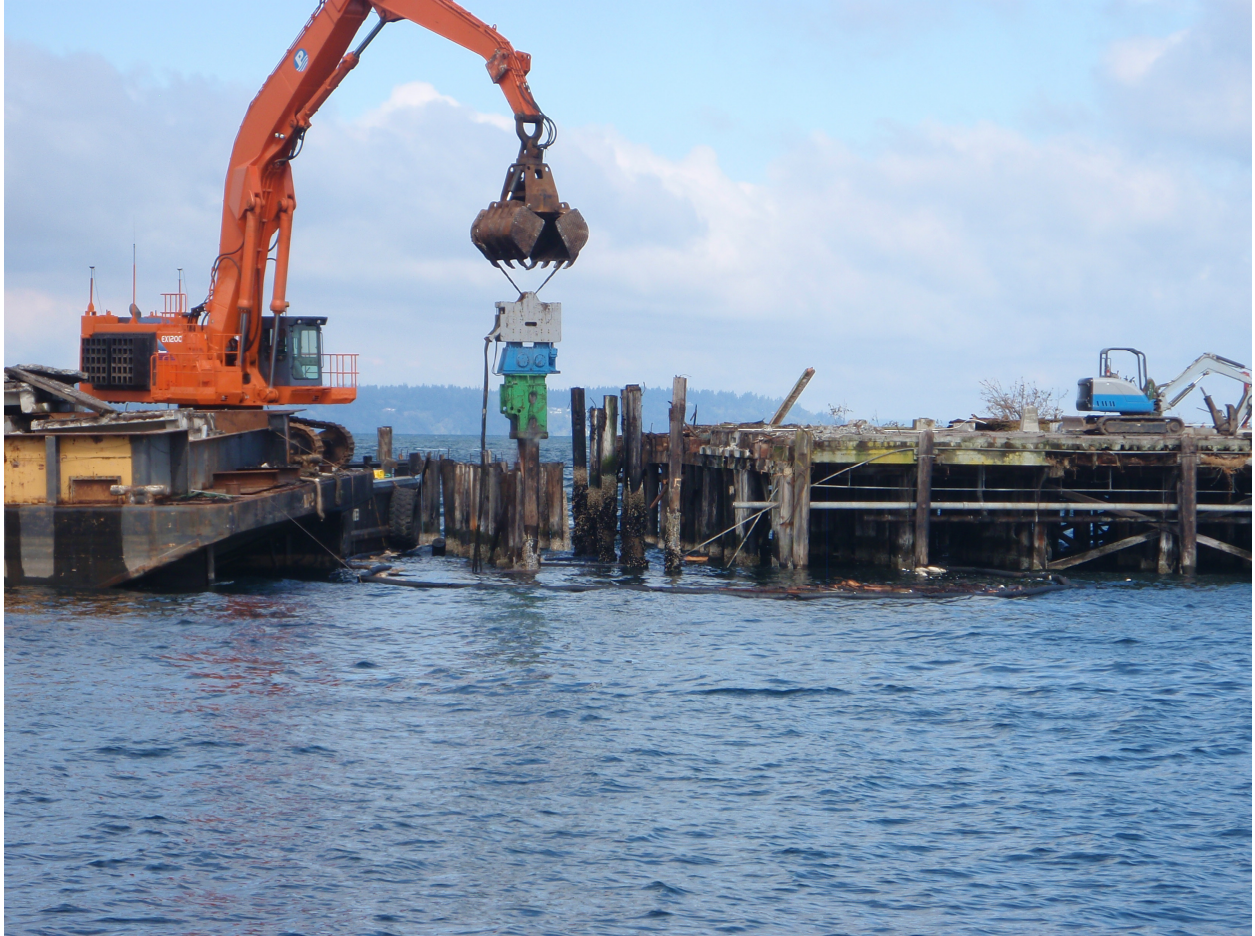
Figure 2-4 Vibratory Hammer Pile Removal

The project included vibratory removal of 12-inch timber piles. Based on in-water measurements at the WSF Port Townsend Ferry Terminal (Laughlin 2011), removal of 12-inch timber piles generated 149 to 152 dB RMS with an overall average RMS value of 150 dB RMS measured at 16 meters. A worst-case noise level for vibratory removal of 12-inch timber piles will be 152 dB RMS at 16 m.

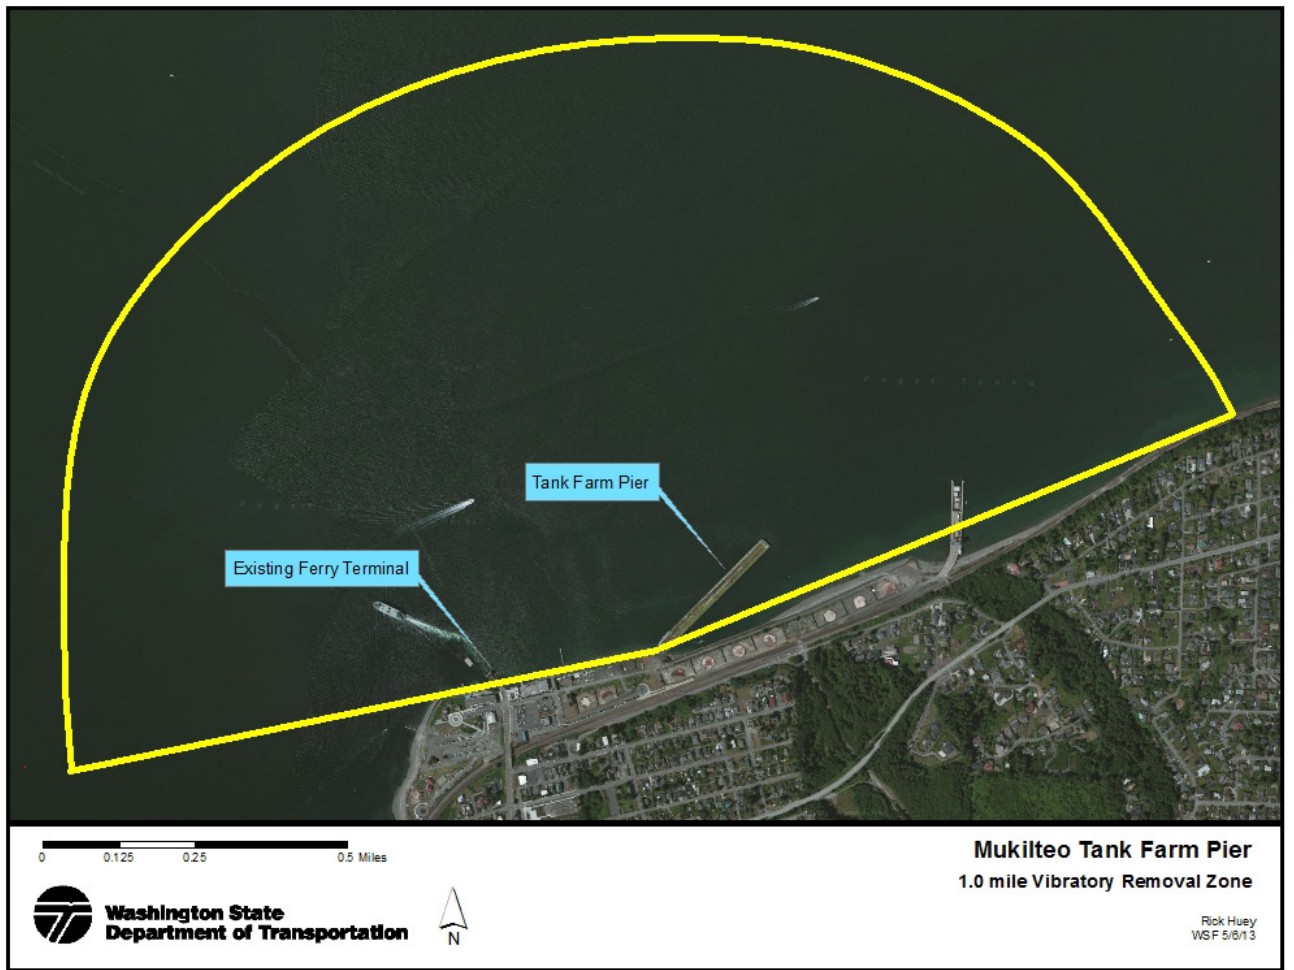
Figure 3-1 Mukilteo Tank Farm Pier Removal Vibratory ZOI

For vibratory pile removal and driving, no injury will occur (source level sounds are less than 180 dB), and so will result in a Level B acoustical harassment zone of influence only. This zone is calculated to extend to the 122 dB RMS in-water background isopleth for vibratory pile removal. Using the NOAA practical spreading model, 152 dB_{RMS} measured at 16m will attenuate to the 122 dB RMS background within ~1 mile (1.6 km) (Figure 3-1).

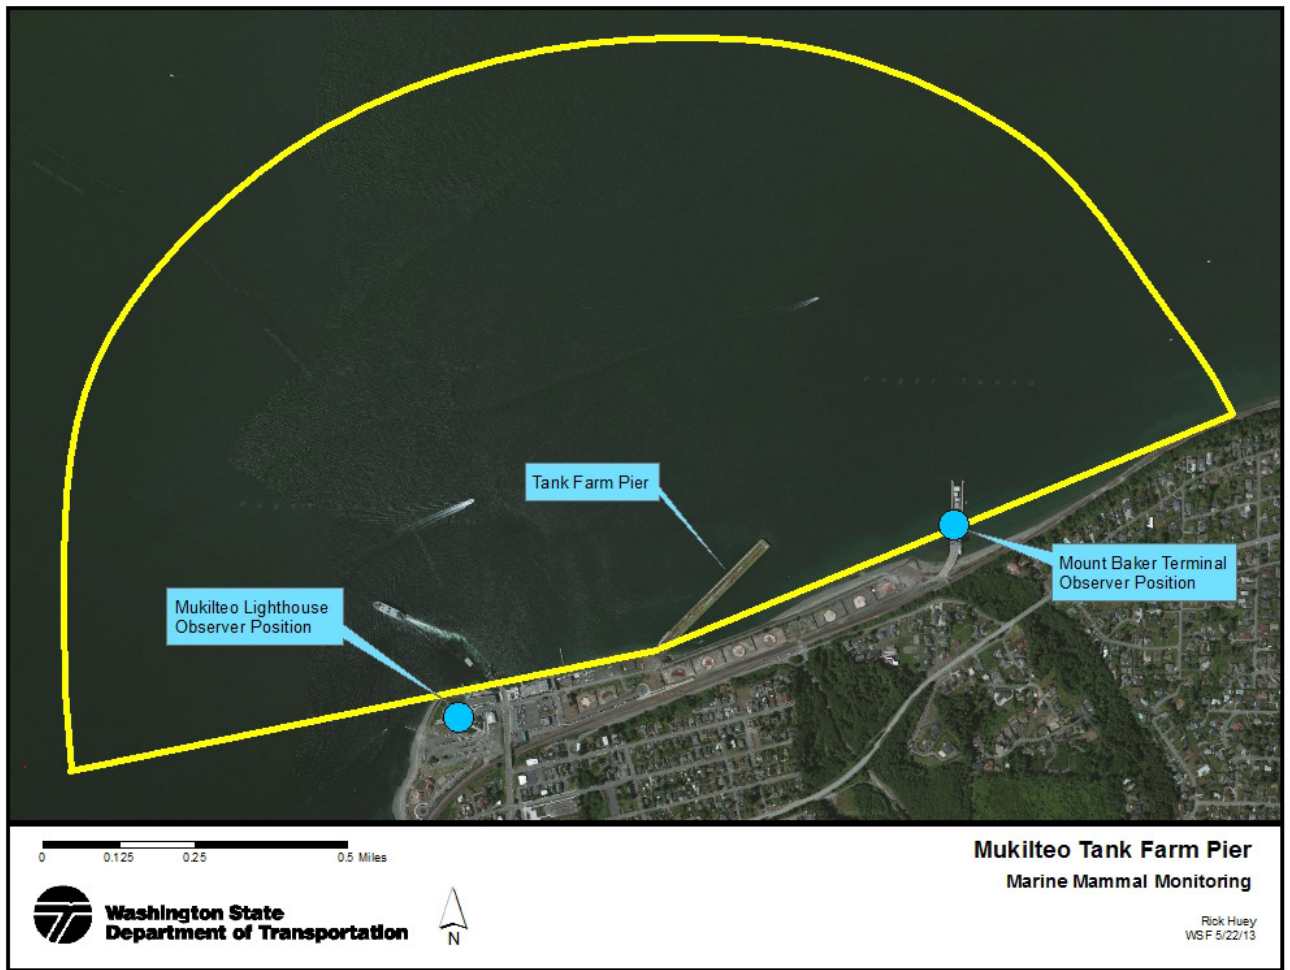
Figure 3-2 Mukilteo Tank Farm Pier Removal Monitoring

- During vibratory pile removal, two land-based biologists monitored the area from the pier and the Mukilteo Lighthouse (Figure 3-2).
- To verify the required monitoring distance, the vibratory Level B acoustical harassment ZOI was determined by using a range finder or hand-held global positioning system device.
- The vibratory Level B acoustical harassment ZOI was be monitored for the presence of marine mammals 30 minutes before, during, and 30 minutes after any pile removal activity.
- Monitoring was continuous unless the contractor took a significant break, in which case, pre-monitoring was repeated (30 minutes) prior to restarting pile removal.
- When marine mammals were observed, their location within the ZOI, and their reaction (if any) to pile-driving activities were documented.
